## **APPENDIX B**

### **EXISTING REACH CONDITIONS AND DATA SUMMARY**

#### **B.1 INTRODUCTION**

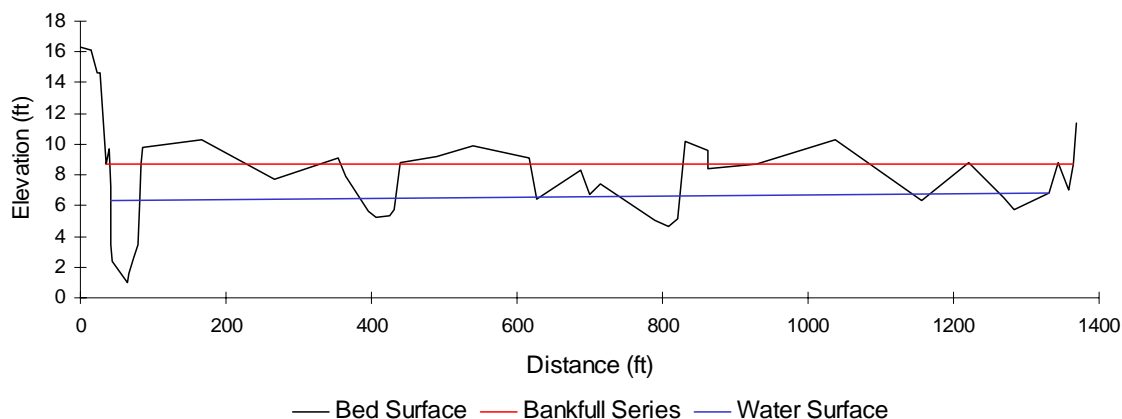
The channel cross-section data reflected the excessively wide, shallow channel morphology resulting from in-channel and upstream sediment delivery. High sediment supply and erodible banks favor formation of a braided channel, as frequent deposition of bars causes lateral channel shifting across the channel bed (Leopold and Wolman, 1957; Leopold et al., 1964). Figure B-3 displays a typical cross-section depicting the dominant channel form in CFR3-A.

**Figure B-3.** Valley cross-section depicting the braided, multiple channel regime in CFR3-A.

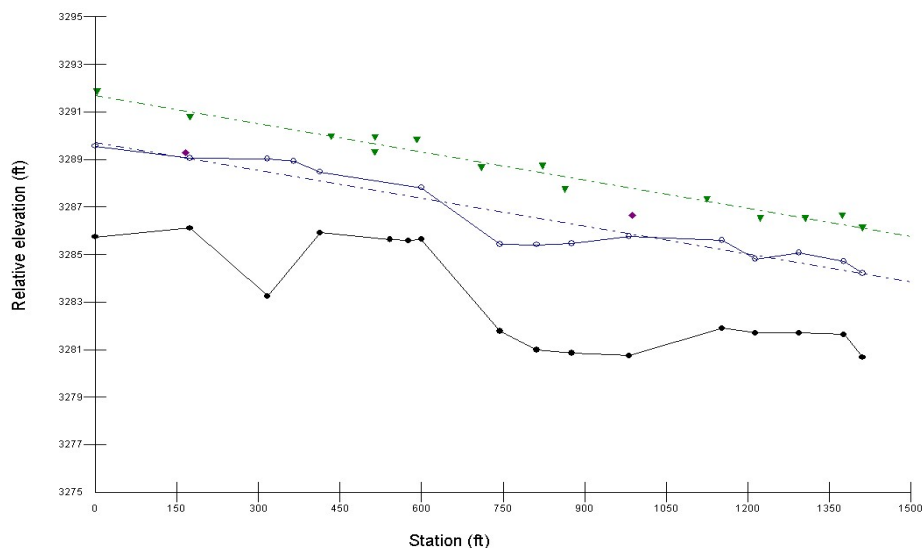
A detailed longitudinal profile was surveyed along 1,300 ft of channel to characterize existing bed morphology associated with the braided channel regime. Figure B-4 presents the longitudinal profile graph depicting the dominant channel thalweg, water surface, and bankfull features. Best-fit trend lines were applied to the water surface and bankfull data.

**Figure B-4.** Longitudinal channel profile graph depicting dominant bed morphology, water surface facet slopes, and bankfull features within CFR3-A. The green points represent the bankfull floodplain with a best-fit line, the blue points are the water surface with a best-fit line, and the black points represent the thalweg.

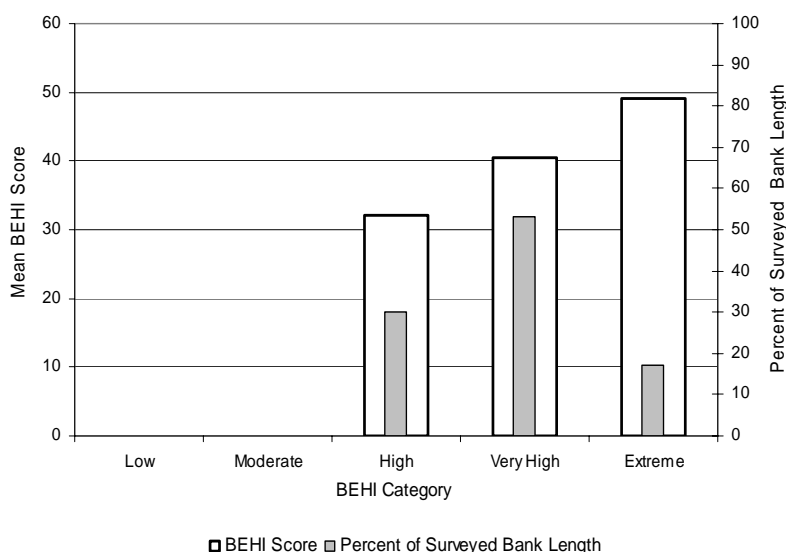
The bank integrity analysis included an evaluation of five bank sites with a total surveyed bank length of approximately 3,000 ft within CFR3-A. The five sites represented the average bank conditions within the reach (Figure B-5).

**Figure B-5.** BEHI scores and ratings for representative bank condition in CFR3-A.

floodplains and low terraces. These results reflect the generally entrenched condition of the channel adjacent to the historical railroad grade on the south side of the floodway. Rooting depth ratio ranged from 0.1 to 0.6 with a mean of 0.4. Weighted root density included values of approximately 2, 13, and 35. Bank angles ranged from 60 to 90 degrees and surface protection from 10 to 80 percent with an average of 42%. Bank material composition was primarily sand with no stratification (Figure B-6). Bank erosion potential at all sampled sites ranged from high to extreme. Numeric BEHI ratings ranged from 30.8 at Site 2 to 49.0 at Site 4.

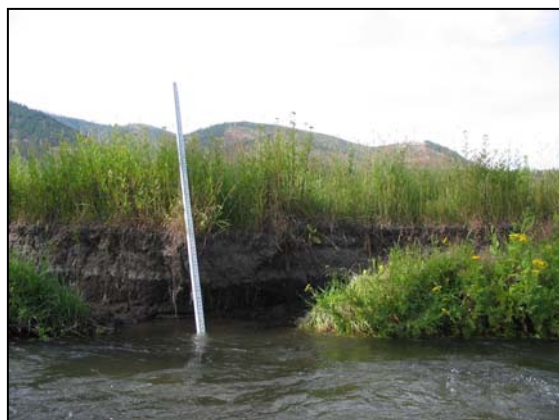
**Figure B-6.** Typical bank condition in CFR3-A. Note lack of woody vegetation and dominance of noxious weed s.

Thirty percent (30%) of the surveyed banks rated high in terms of bank erosion potential, 53% very high, and 17% extreme. The frequency of eroding banks appeared to correlate with degraded vegetation conditions on the floodplains and low terraces.

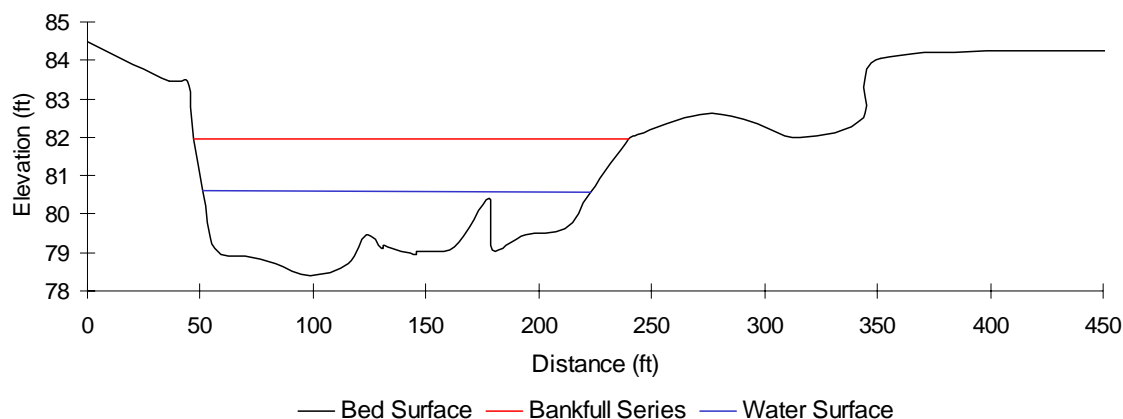
Pool habitat units were generally wider and deeper than riffle units, as expected. Bankfull pool width ranged from 170 ft to 213 ft. with maximum depths of 7.3 ft to 7.6 ft. Average bankfull cross-sectional area was 648 ft<sup>2</sup>, approximately 13% greater than riffle habitat units. Glide habitat units corresponded to pool tailouts and were generally wider and shallower than riffle, pool and run habitat units. Bankfull widths for glides ranged from 156 ft to 327 ft, with average depths ranging from 2.0 ft to 3.7 ft. Runs were identified as areas where the profile transitioned from riffle to pool habitat units, and had the least cross-sectional area of all sampled habitat units (average of 503 ft<sup>2</sup>). Bankfull run widths ranged from 126 ft to 167 ft with mean depths of 2.9 ft to 3.7 ft.

**Figure B-7.** Cross-section depicting the typical channel morphology (riffle habitat unit) in CFR3-B.

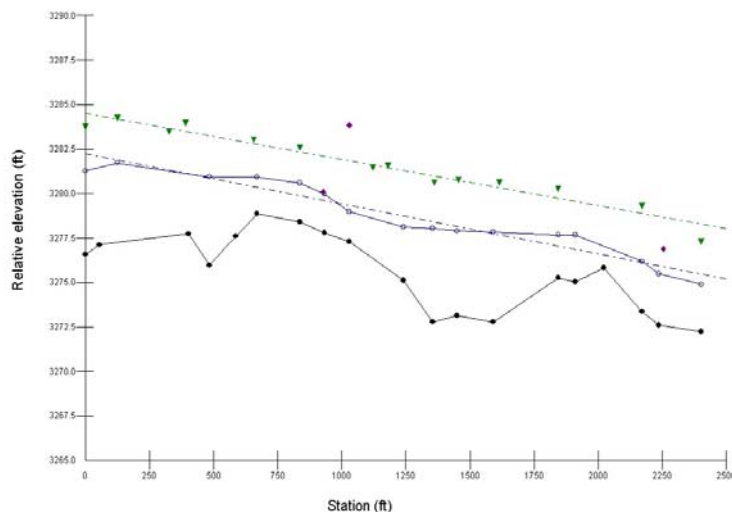
Longitudinal profile data were collected on a 2,400 ft representative reach of CFR3-B (Figure B-8). Features including channel thalweg, water surface, and bankfull floodplains were surveyed to characterize the channel profile. Bedform morphology was characterized by an undulating thalweg transitioning between pool and riffle sequences. Pools were formed primarily by flow through meander bends with bank vegetation consisting of the cottonwood/red osier dogwood (*Populus trichocarpa*/*Cornus stolonifera*) habitat type (Hansen et al., 1995).

**Figure B-8.** Longitudinal channel profile graph depicting dominant bed morphology, water surface facet slopes, and bankfull features within CFR3-B. The green points represent the bankfull floodplain with a best-fit line, the blue points are the water surface with a best-fit line, and the black points represent the thalweg.

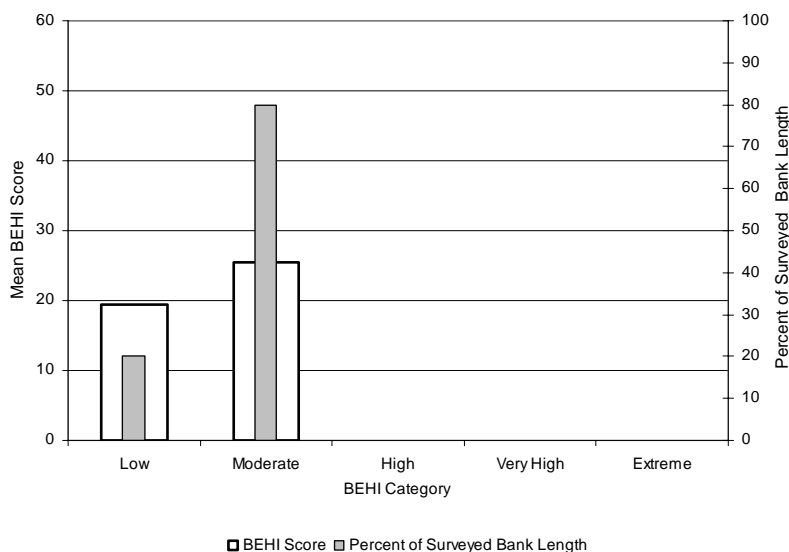
The bank integrity analysis included an evaluation of three bank sites with a total surveyed bank length of approximately 2,000 ft within CFR3-B (Figure B-9). The surveyed sites were representative of the average streambank conditions in CFR3-B.

**Figure B-9.** BEHI scores and ratings for representative bank condition sites in CFR3-B.

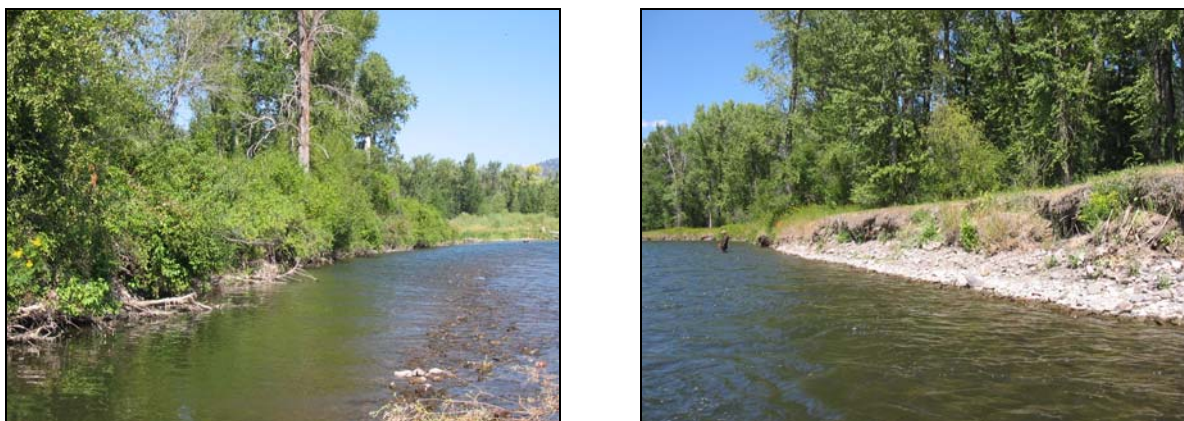
Bank height ratios ranged from 1.2 to 1.4. Root depth ratio ranged from 0.2 to 0.6 with corresponding weighted root density values of 8, 31, and 2. Bank angles ranged from 60 to 80 degrees and surface protection from 39 to 70 percent. Bank material composition consisted of gravel with little to no sand or unstable strata.

**Figure B-10.** Photos of representative streambank conditions within CFR3-B.

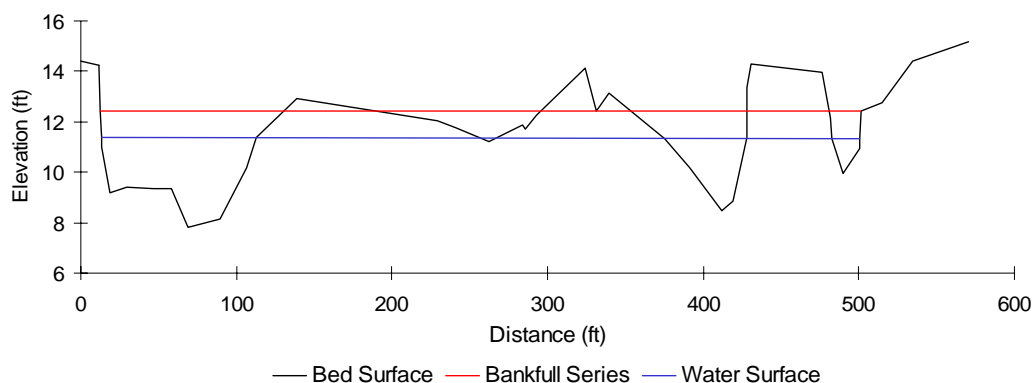
Habitat Type (n)	Bankfull width (ft)	Average depth (ft)	Width-to- depth ratio	Maximum depth (ft)	Cross-sectional area (ft <sup>2</sup> )
Riffle (3)	475 (400-529)	2.2 (1.8-2.4)	214 (204-220)	6.3 (5.0-8.6)	1,076 (729-1,291)

**Figure B-11.** Cross-section depicting the braided channel morphology in CFR3-C.

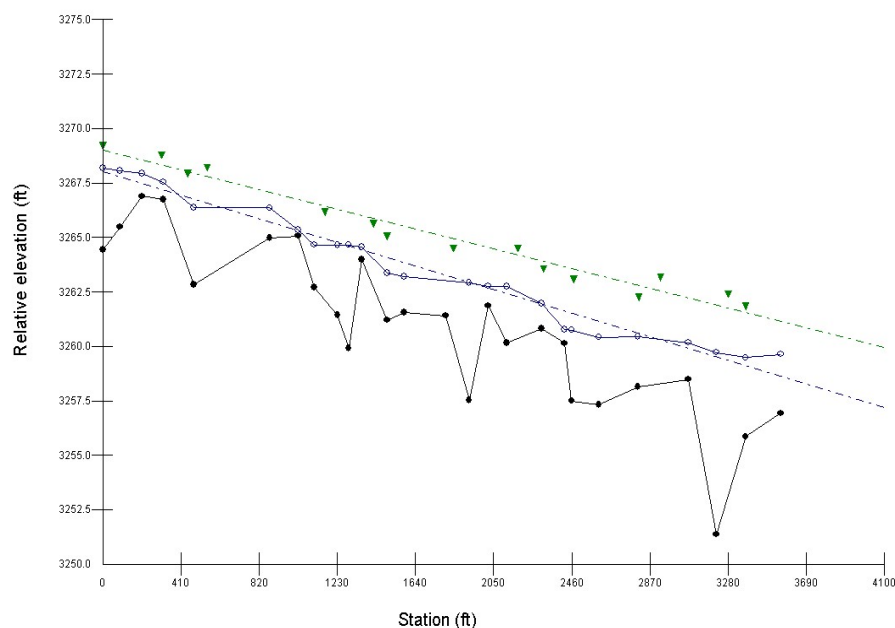
The channel profile survey included approximately 3,700 ft of CFR3-C. Figure B-12 presents the longitudinal profile graph depicting thalweg, water surface, and bankfull features. Best fit lines were applied to the water surface and bankfull data. As noted, the bedform was comprised of closely spaced riffle and pool sequences formed by converging flow lines and localized scour. Extensive mid-channel bars caused the flow to diverge at the apex of the deposits and converge with opposing flow lines, causing localized bed scour. Similar to CFR3-A, the bedforms were high unstable, with frequent shifts across the active belt width.

**Figure B-12.** Longitudinal channel profile graph depicting dominant bed morphology, water surface facet slopes, and bankfull features within CFR3-C. The green points represent the bankfull floodplain with a best-fit line, the blue points are the water surface with a best-fit line, and the black points represent the thalweg.

Longitudinal profile data are summarized in Table B-19 and B-20. Average water surface slope was 0.003 ft/ft. Riffle slope were steeper, averaging 0.007 or 2.3 times the average water surface slope. Stable pool features were not observed during the reach survey and were therefore excluded from the analysis.

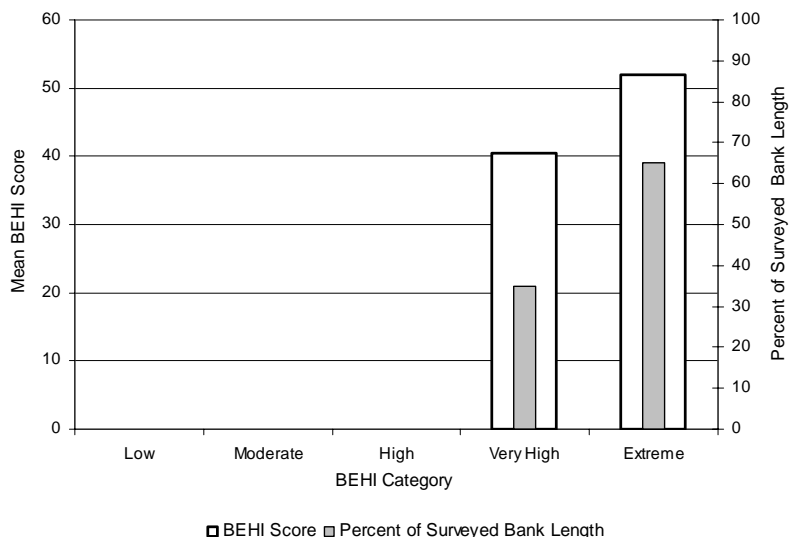
The bank integrity analysis included an evaluation of four bank sites with a total surveyed bank length of approximately 1,700 ft within CFR3-C. Bank erosion potential ranged from very high (35%) to extreme (65%). Numeric BEHI ratings ranged from 40.5 at Site 3 to 53.2 and Site 2. Figure B-13 summarizes the results for CFR3-C.

**Figure B-13.** BEHI scores and ratings for representative bank condition sites in CFR3-C.

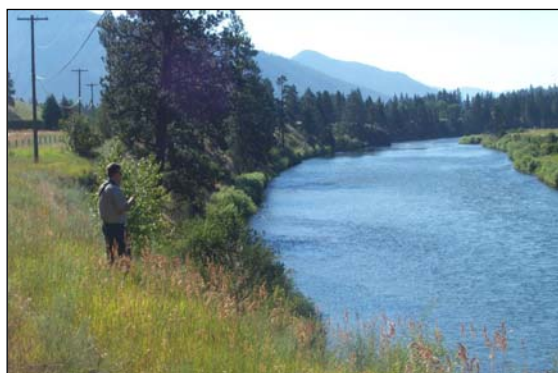
Located downstream of the CFR-BFR confluence, the Bandmann Flats reach experiences a much greater flow regime than CFR2 and CFR3. The bankfull discharge triples in magnitude relative to CFR2 and CFR3, with an estimated flow rate of 10,400 cfs. The morphology of the river likewise reflects this increase in stream order, with bankfull riffle channel widths increasing from an average of 183 ft in CFR3-B to 239 ft in Bandmann Flats.

**Figure B-14.** View of CFR1 at Bandmann Flats looking upstream towards the Interstate 90 bridge from Highway 200. The channel is confined to the north by a glacial outwash terrace and maintains a relatively narrow floodprone area.

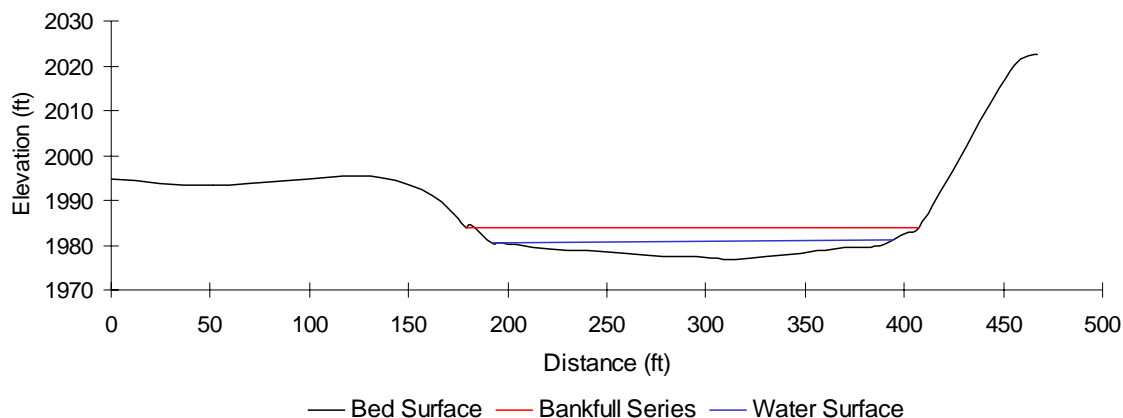
Runs were identified as areas where the profile transitioned from riffle to pool habitat units, and had the least cross-sectional area of all sampled habitat units (average of 1,299 ft<sup>2</sup>). Bankfull run widths ranged from 217 ft to 224 ft with mean depths of 5.8 ft to 6.0 ft.

**Figure B-15.** Typical riffle cross-section in CFR1 at Bandmann Flats.

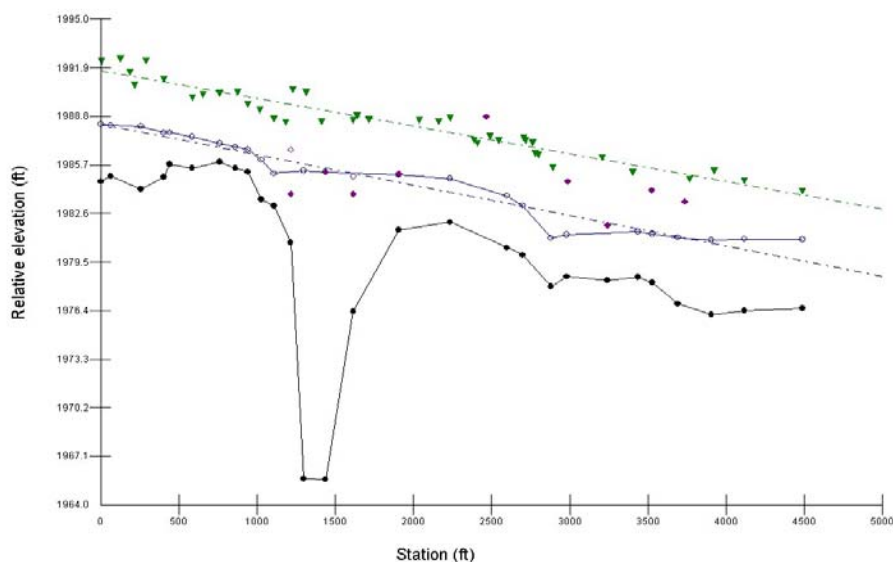
The channel profile at Bandmann Flats included approximately 4,500 ft of channel (Figure B-16). The most prominent feature captured in the survey was a large scour pool measuring 24.7 ft in depth formed by a bedrock outcrop on the north side of the channel. The outcrop constricted the bankfull channel width causing rapid flow contraction and bed scour.

**Figure B-16.** Longitudinal channel profile graph depicting dominant bed morphology, water surface facet slopes, and bankfull features within CFR1 at Bandmann Flats. The green points represent the bankfull floodplain with a best-fit line, the blue points are the water surface with a best-fit line, and the black points represent the thalweg.

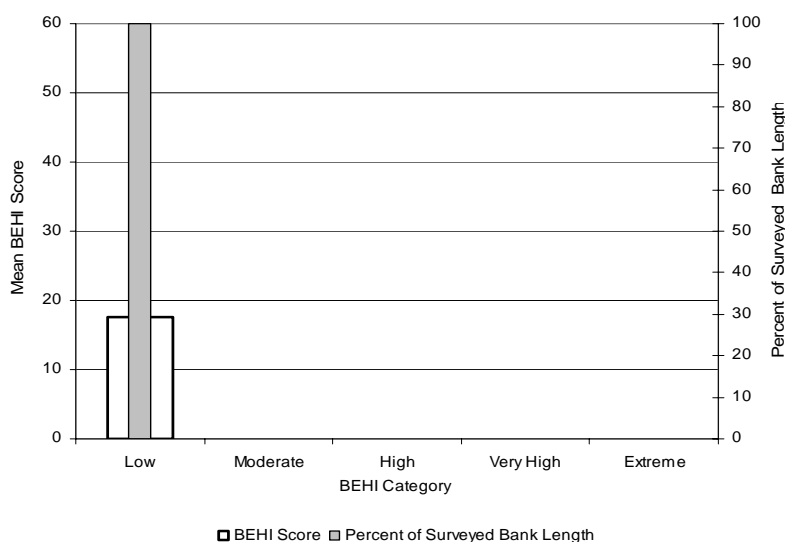
The bank integrity analysis included an evaluation of four bank sites with a total surveyed bank length of approximately 2,900 ft within CFR at Bandmann Flats. Figure B-17 summarizes the results for CFR at Bandmann Flats. Bank erosion potential at all sampled sites was low. Numeric BEHI ratings included 19.2 at Site 1, 19.1 at Site 2, 15.8 at Site 3 and 16.4 at Site 4.

**Figure B-17.** BEHI scores and ratings for representative bank condition sites in CFR1 at Bandmann Flats.

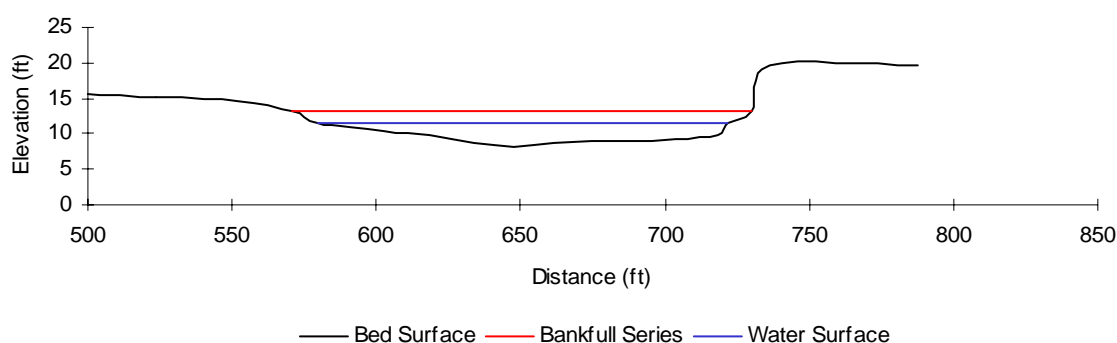
Habitat Type (n)	Bankfull width (ft)	Average depth (ft)	Width-to-depth ratio	Maximum depth (ft)	Cross-sectional area (ft <sup>2</sup> )
Riffle (3)	168 (154-184)	3.2 (2.9-3.5)	53 (44-64)	4.6 (3.9-5.0)	541 (529-552)
Pool (4)	140 (122-151)	3.7 (3.5-3.9)	n/a	7.8 (6.3-10.8)	518 (429-584)
Run (3)	155 (134-173)	3.6 (3.0-4.6)	n/a	6.7 (6.2-6.9)	554 (465-616)
Glide (4)	196 (123-283)	3.1 (2.7-3.8)	n/a	5.0 (4.0-6.6)	580 (466-759)

**Figure B-19.** Typical riffle cross-section in Reach 1.

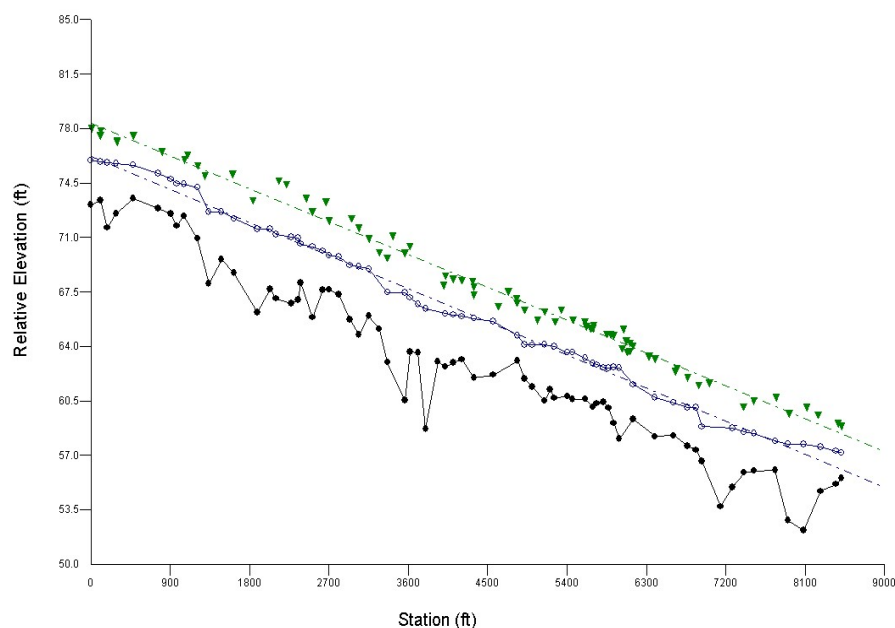
Longitudinal profile data were collected on a 8,500 ft representative segment of Reach 1. Features including channel thalweg, water surface, and bankfull floodplains were surveyed to characterize the channel profile. Bedform morphology was characterized by an undulating thalweg transitioning between pool and riffle sequences. Pools were formed primarily by flow through meander bends and lateral scour. Figure B-32 presents the longitudinal profile graph.

**Figure B-20.** Longitudinal channel profile graph depicting dominant bed morphology, water surface facet slopes, and bankfull features within Reach 1. The green points represent the bankfull floodplain with a best-fit line, the blue points are the water surface with a best-fit line, and the black points represent the thalweg.

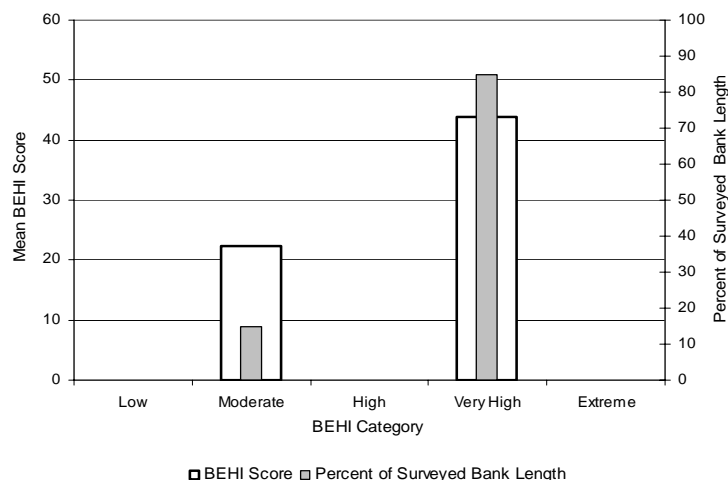
The bank integrity analysis included an evaluation of four bank sites with total surveyed bank length of approximately 2,085 feet within Reach 1 (Figure B-21). Bank height ratios ranged from 1.4 to 2.0, with the exception of Site 2 with a bank height ratio of 4.7. Root depth ratios ranged from 0.1 to 0.4. Weighted root density included values of 0.4, 1.0, 5, and 28.9. Bank angles generally ranged from 80 to 90 degrees; bank angle at Site 1 was 60 degrees. Typical surface protection was 50 to 70 percent; surface protection at Site 1 was 10 percent.

**Figure B-21.** BEHI scores and ratings for representative bank condition sites in Reach 1.

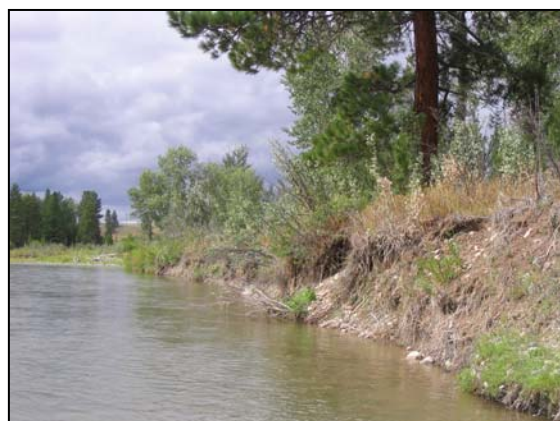
Bank material composition was primarily gravel with a high fraction of sand and unstable strata. Figure B-22 includes photos of a representative streambank conditions in Reach 1.

**Figure B-22.** Typical streambank condition in Reach 1 of the BFR near Ovando study area. This site rated moderate in terms of bank erodability potential.

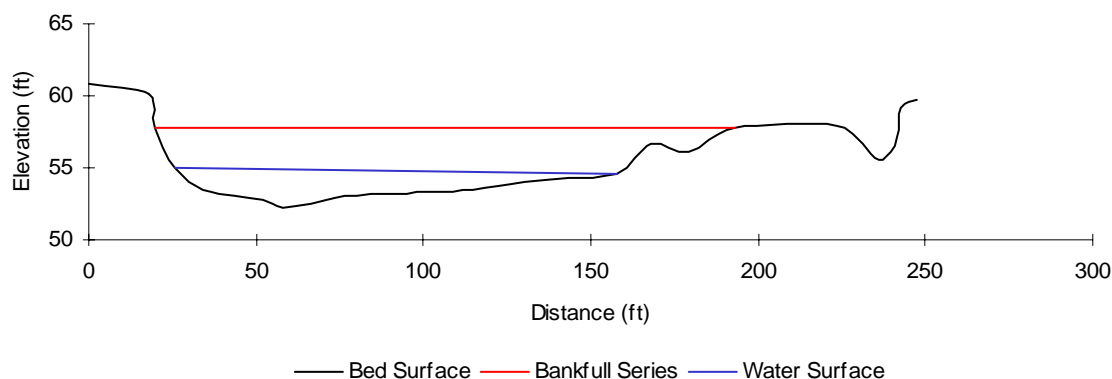
Nine channel cross-sections were surveyed in Reach 2. Four cross-sections were surveyed in riffle units and two in run and glide units. Due to the relatively short reach length, only one pool was observed. Bankfull riffle habitat unit widths ranged from 178 ft to 217 ft, with corresponding width-to-depth ratios ranging from 38-73, respectively. Maximum riffle depths ranged from 3.8 ft to 5.6 ft with an average value of 4.7 ft. Average bankfull cross-sectional area for riffle habitat units was 575 ft<sup>2</sup>, ranging from 498 ft<sup>2</sup> to 655 ft<sup>2</sup>. Table B-37 summarizes the data. Figure B-23 depicts a typical riffle cross-section.

Bankfull pool width was 177 ft with a maximum depth of 7.9 ft. Pool bankfull cross-sectional area was 633 ft<sup>2</sup>. Bankfull glide widths ranged from 143 ft to 153 ft, with average depths ranging from 3.6 ft to 3.7 ft. Runs were identified as areas where the profile transitions from riffle to pool habitat units. Average run cross-sectional area was 600 ft<sup>2</sup>. Bankfull run widths ranged from 152 ft to 161 feet with mean depths of 3.4 ft to 4.3 ft.

**Figure B-23.** Typical riffle cross-section in Reach 2 of the BFR near Ovando.

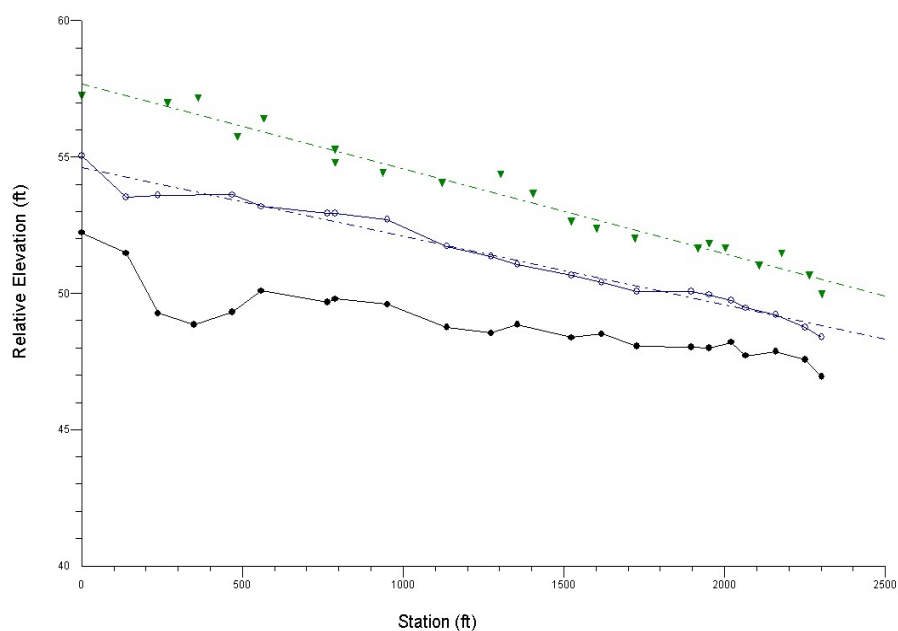
Longitudinal profile data were collected on a 2,300 ft representative segment of Reach 2. Features including channel thalweg, water surface, and bankfull floodplains were surveyed to characterize the channel profile. Bedform morphology was characterized by riffles and irregularly spaced scour pools associated with large cobble and boulder lag deposits. Figure B-24 presents the longitudinal profile graph. As noted, the profile was fairly homogenous with a majority of the habitat composed of riffle and run morphology.

**Figure B-24.** Longitudinal channel profile graph depicting dominant bed morphology, water surface facet slopes, and bankfull features within Reach 2. The green points represent the bankfull floodplain with a best-fit line, the blue points are the water surface with a best-fit line, and the black points represent the thalweg.

Longitudinal channel profile data are summarized in Table B-38 and B-39. Average water surface slope was 0.0025 ft/ft. Average riffle and pool slopes were 0.0053 ft/ft and 0.0008 ft/ft respectively. Riffle slopes were over-steepened by approximately 210% relative to the average water surface slope, and pools were flatter or approximately 30% of the average water surface slope. The ratios of riffle and pool slopes to average slope were 2.12 and 0.32, respectively.

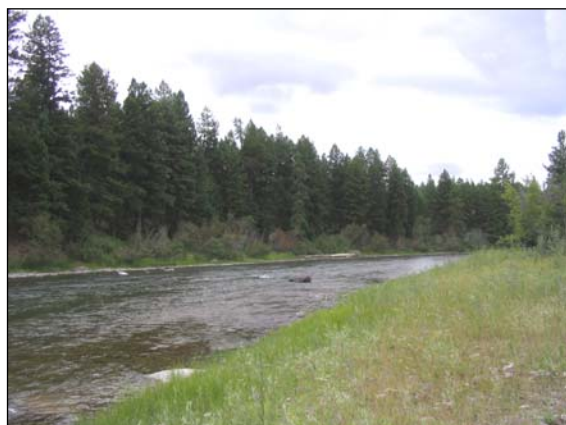
**Figure B-25.** Pool habitat within Reach 2 was primarily formed and maintained by large cobble and boulder lag deposits resulting from continental glaciation.

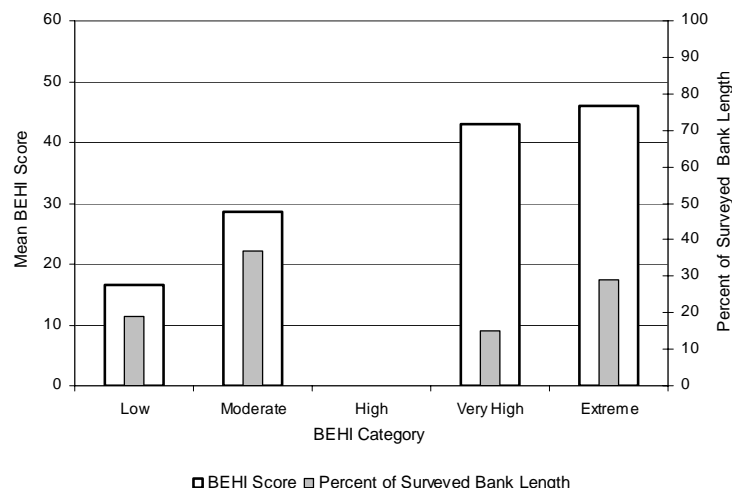
The bank integrity analysis included an evaluation of four bank sites with a total surveyed bank length of approximately 2,330 feet within Reach 2. Figure B-26 summarizes the results. Bank erosion potential ranged from low to extreme. Numeric BEHI ratings included 28.7 at Site 1, 46.1 at Site 2, 43.1 at Site 3, and 16.6 at Site 4. Nineteen percent (19%) of the surveyed banks rated low in terms of bank erosion potential, 36% rated moderate, 15% very high and 29% extreme.

**Figure B-26.** BEHI scores and ratings for representative bank condition sites in Reach 2.

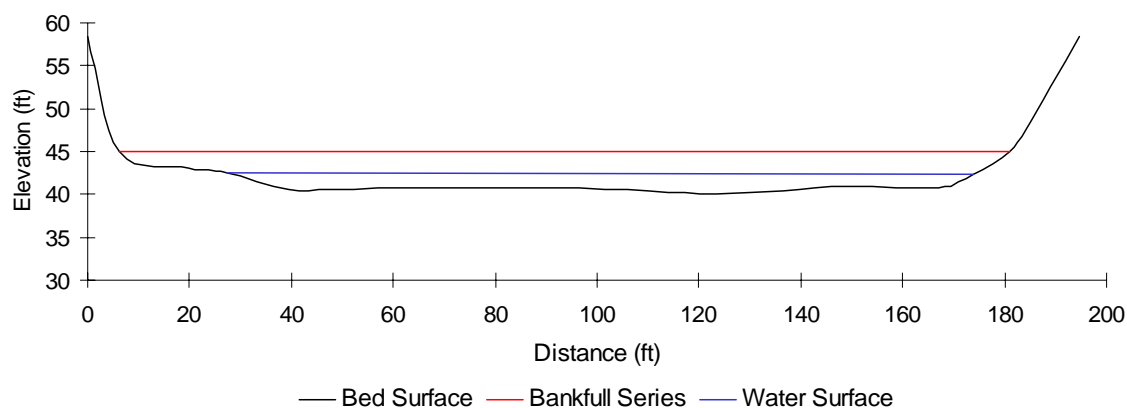
Two pool cross-sections were surveyed. Average bankfull widths of pool habitat units were generally narrower than riffle units and associated with valley and channel constrictions. Bankfull pool width ranged from 164 ft to 184 ft with maximum depths of 6.4 ft to 7.3 ft. Average bankfull cross-sectional area was 712 ft<sup>2</sup>, approximately 30% greater than riffle habitat units. Bankfull widths for glides were the widest feature and ranged in width from 179 ft to 252 ft. One run was identified in the survey. A typical cross-section is displayed in Figure B-27.

**Figure B-27.** Typical riffle cross-section in Reach 3.

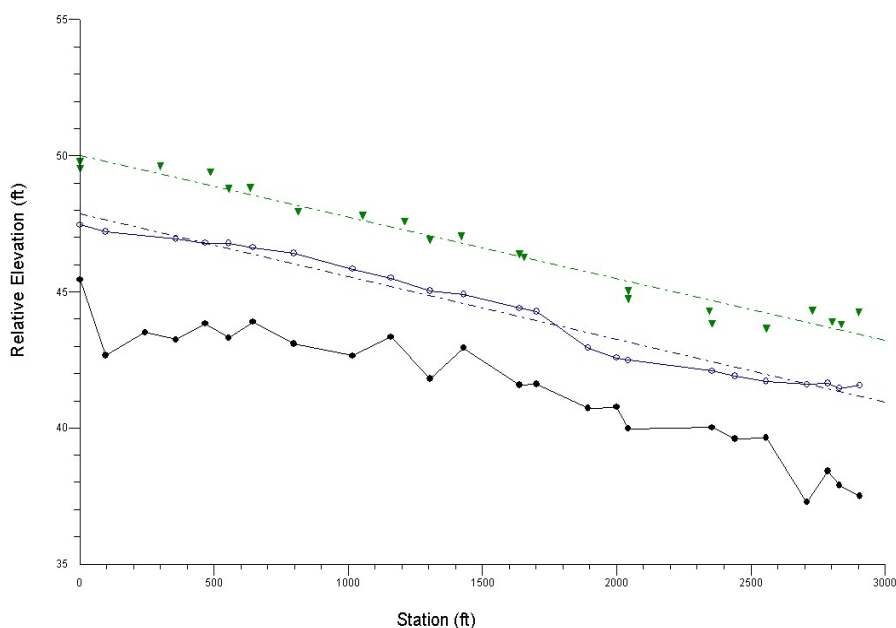
The longitudinal profile for Reach 3 is depicted in Figure B-28 and included approximately 2,900 ft of channel. Similar to Reach 2, the F4 channel type was comprised of irregularly spaced riffle and pool sequence formed by large cobble and small boulder substrates resulting from continental glaciation. The frequency of pocket pools is shown in the bed profile. The larger sampled pools were associated with dipping bedrock along the thalweg of the meander outcures.

**Figure B-28.** Longitudinal channel profile graph depicting dominant bed morphology, water surface facet slopes, and bankfull features within Reach 3. The green points represent the bankfull floodplain with a best-fit line, the blue points are the water surface with a best-fit line, and the black points represent the thalweg.

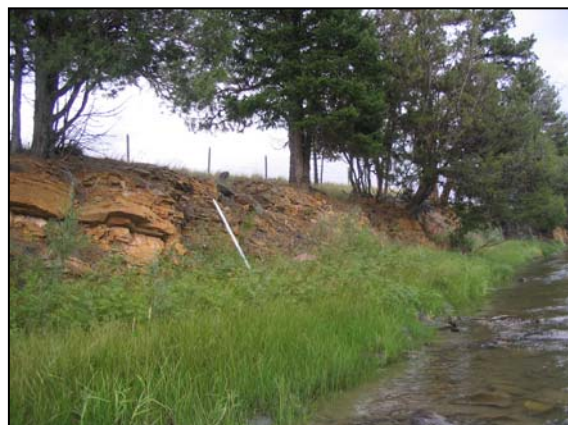
conditions within Reach 3, including bedrock formed hillslopes and unconsolidated glacial till and lacustrine mantled slopes (Figure B-29). Figure B-30 summarizes the results. Bank erosion potential for the reach was low to moderate. Slopes mantled with till and finer grained sediments were typically well vegetated offering sufficient bank surface protection from high flows. Numeric BEHI ratings included 18.4 at Site 1 and 21.5 at Site 2.

**Figure B-29.** Bank material composition in Reach 3 ranged from sandy gravel to resistant sedimentary bedrock exposures.

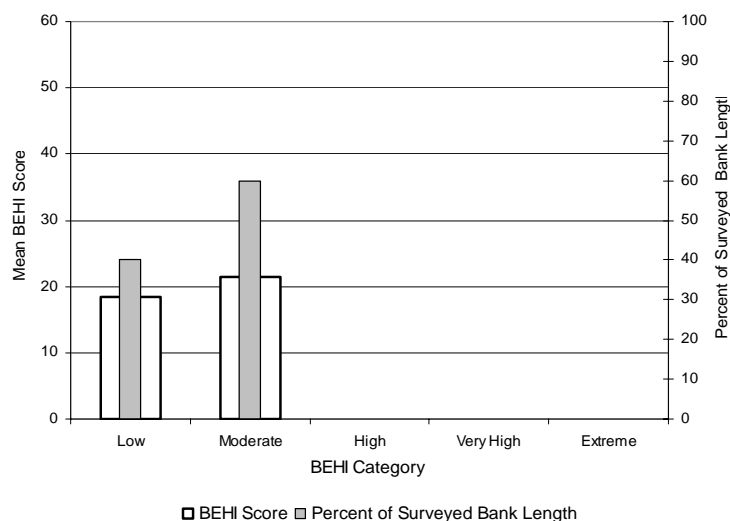
**Figure B-30.** BEHI scores and ratings for representative bank condition sites in Reach 3.

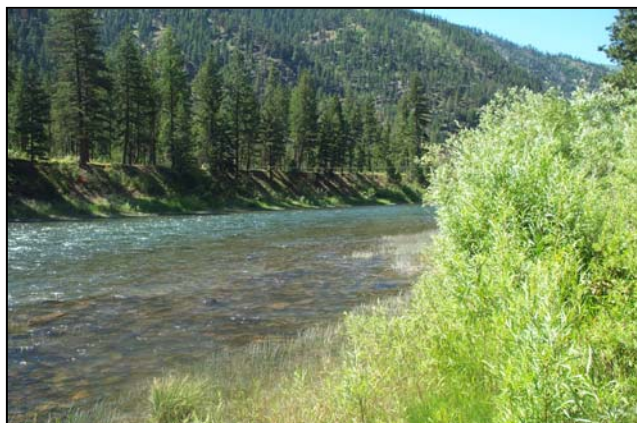
The BFR flows through a moderately confined valley in the vicinity of the USGS gaging station near Bonner. The channel has incised into unconsolidated, heterogeneous and erodible glacial outwash terraces that provide a continual source of sediment to the channel in locations where the river interacts with the terrace. Upstream and downstream of the assessed reach, the Highway 200 road fill periodically encroaches on the channel, displacing what minimal floodplain was present prior to construction of the transportation corridor. A majority of the reach was characterized by riffle, run and glide habitat units. Channel-spanning pools were absent in the reach, yet similar to Reach 3 of the BFR near Ovando, coarse lag deposits resulting from continental glaciation formed frequent and irregularly spaced scour pools. Riffle and run bedforms characterized the bed profile and sediment supply derived from the channel bed was considered low. The reach classified as an entrenched F3 channel type and in locations where floodplain was developed, a moderately entrenched B3 channel type predominated.

**Figure B-31.** View of the BFR at the USGS gaging station. The floodplain in the foreground supported dense riparian shrubs. The opposite bank was a glacial outwash terrace standing approximately 4-8 ft from the current bankfull elevation of the river.

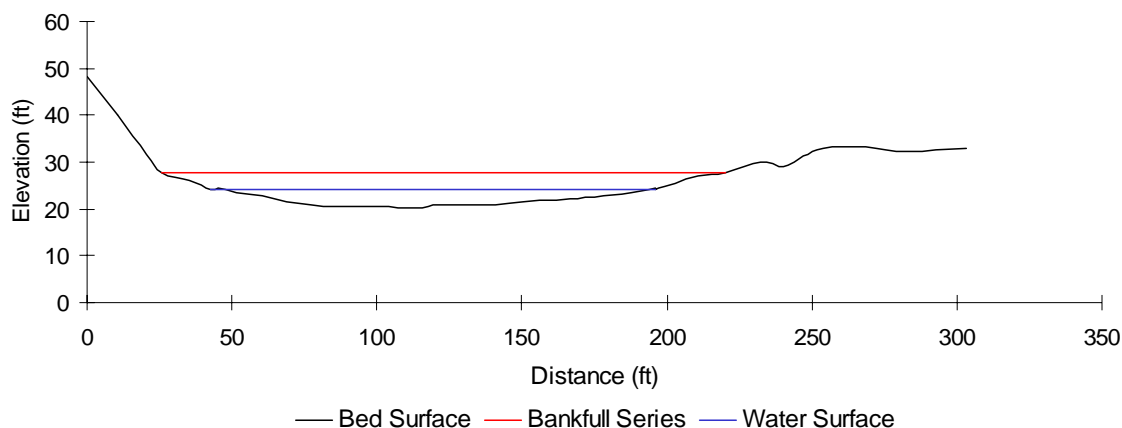
ft, with average depths ranging from 4.9 ft to 5.2 ft. The one sampled run habitat unit was 216 ft in width with an average depth of 5.0 ft and maximum depth of 9.8 ft.

**Figure B-32.** Typical riffle cross-section of the BFR at the USGS gaging station near Bonner.

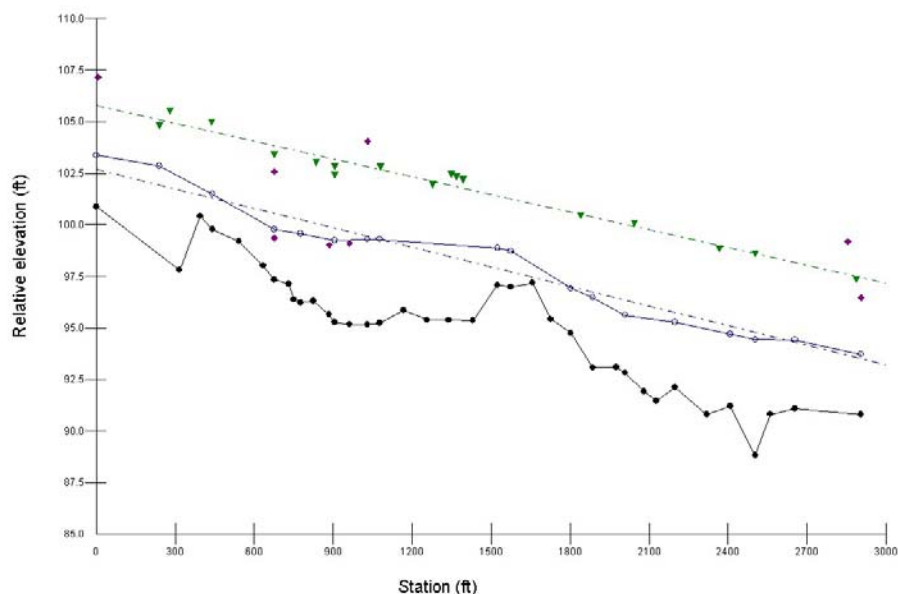
The channel profile is depicted in Figure B-33 and included approximately 2,800 ft of channel. The USGS gaging station was located at Station 8+00 and associated with a stable, glide habitat unit. The low and medium stage control for the cross-section is a broad cobble and small boulder riffle located approximately 700 ft downstream at Station 15+00. As noted, no significant pools were measured during the survey and bedforms were largely characterized by irregularly spaced scour pools and riffle habitat units. The reach was void of large woody debris.

**Figure B-33.** Longitudinal channel profile graph depicting dominant bed morphology, water surface facet slopes, and bankfull features within Reach 1. The green points represent the bankfull floodplain with a best-fit line, the blue points are the water surface with a best-fit line, and the black points represent the thalweg.

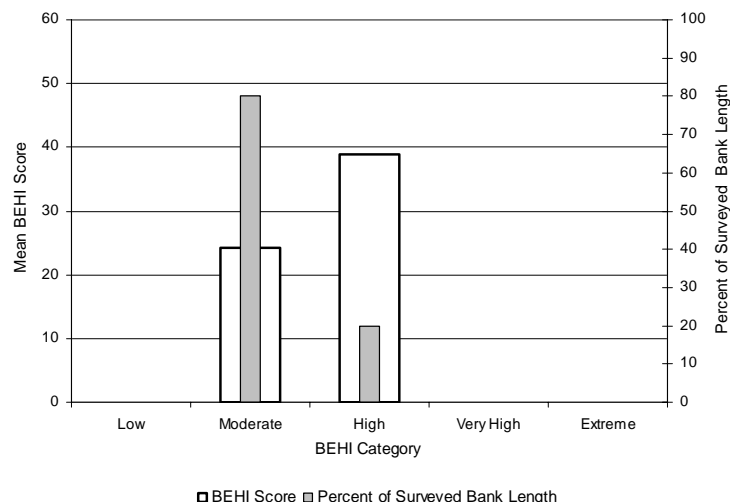
**Figure B-34.** BEHI scores and ratings for representative bank condition sites of the BFR at the USGS gage station near Bonner.

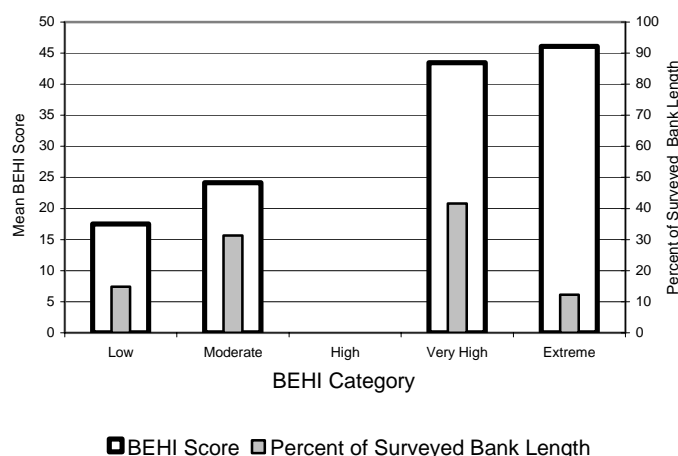
**Figure B-35.** Composite BEHI scores and ratings for the Blackfoot River near Ovando, Reaches 1, 2 and 3.
